# FACILITY COMPLIANCE INSPECTION REPORT

## Division of Waste Management Solid Waste Section

**Date of Site Inspection:** July 11, 2013

Bladen County Landfill, 1522 Mercer Mill Road, Elizabethtown, NC 28337

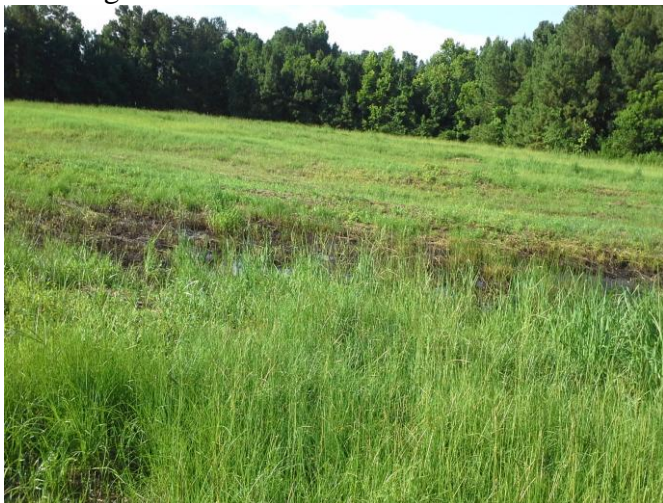
1. The facility had been mowed since the previous inspection.
2. There were several settled areas about the landfill where ponding water was observed during this inspection.

One of the settled areas on the closed MSWLF.

3. Maintaining the integrity and effectiveness of the cap system should begin, including making repairs to the cover as necessary to correct the effects of settlement, subsidence, erosion or other events and preventing run-on and run-off from eroding or otherwise damaging the cap system in accordance with 15A NCAC 13B 1627 (d). Measures to repair the cap should commence as conditions allow.

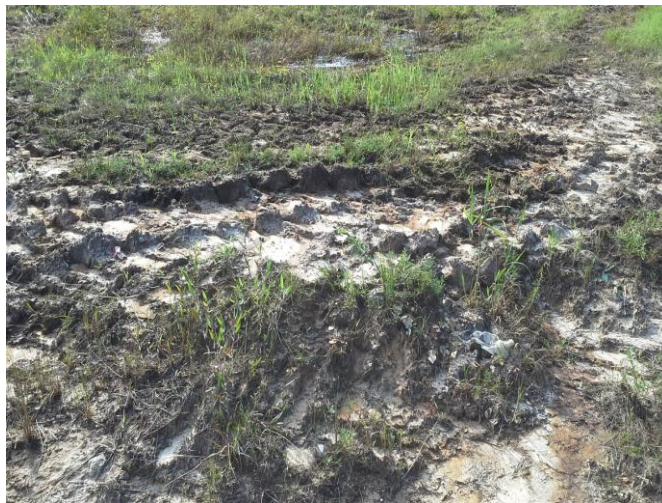
Eroded area on W side of closed MSWLF.

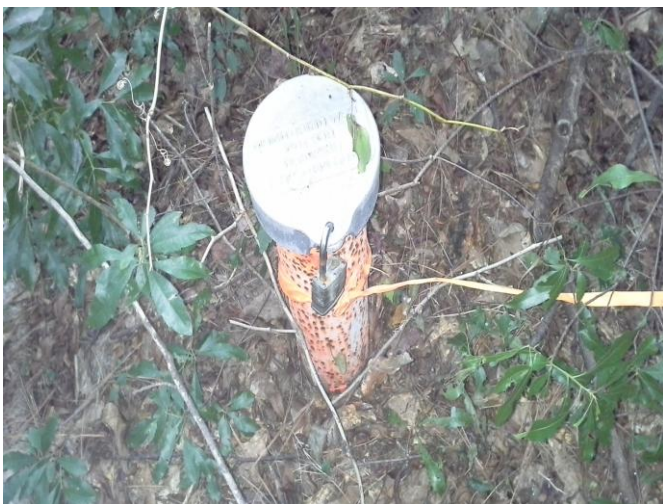
GW MW unlocked, no well record or label.

4. All non-water supply wells, including temporary wells, shall be secured with a locking well cap to ensure against unauthorized access and use in accordance with 15A NCAC 2C .0108 (n).

5. Each non-water supply well shall have permanently affixed an identification plate. The identification plate shall be constructed of a durable, waterproof, rustproof metal or other material approved by the Department as equivalent and pertinent information in accordance to 15A NCAC 2C .0108 (o).

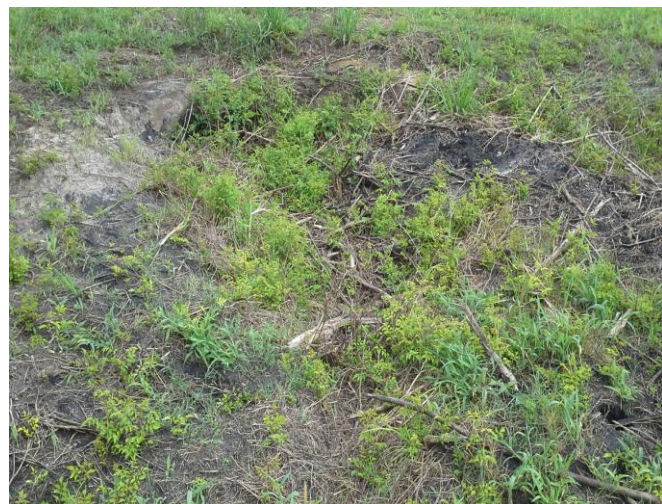
Small sink hole on east side slope of CMSWLF.
